MILL BROW

CONSERVATION AREA CHARACTER APPRAISAL

April 2007 (updated 2013)

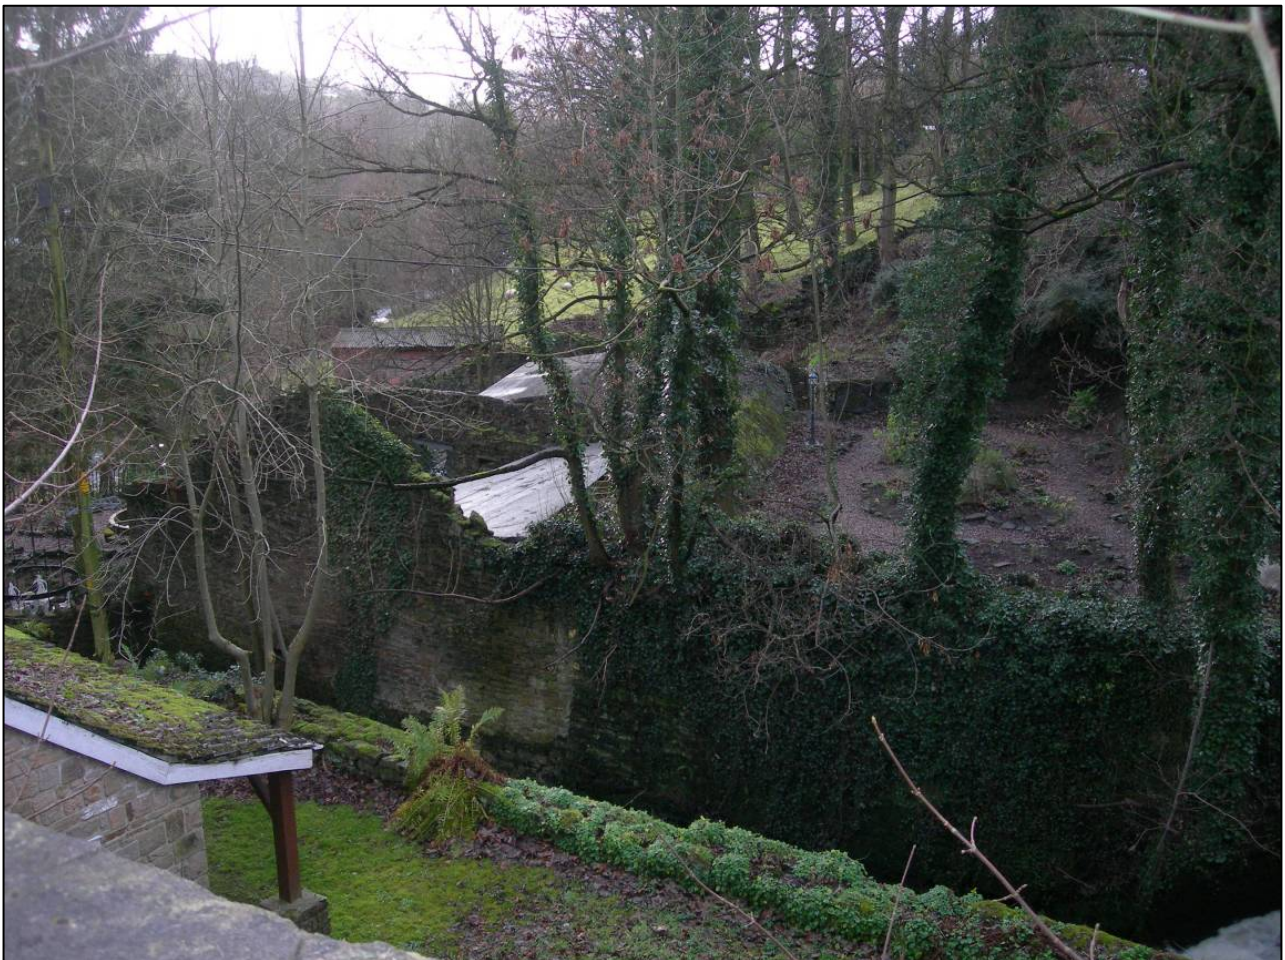
Remains of Holly Vale Mill

Established by 1803, and owned by four generations of Ratcliffe family until ceased production c 1900. Originally used for cotton spinning, with candlewick making added by mid-19th century and bleaching added c 1876. Stone walling, roofless one storey mill building and weir remain. Of industrial archaeological interest.

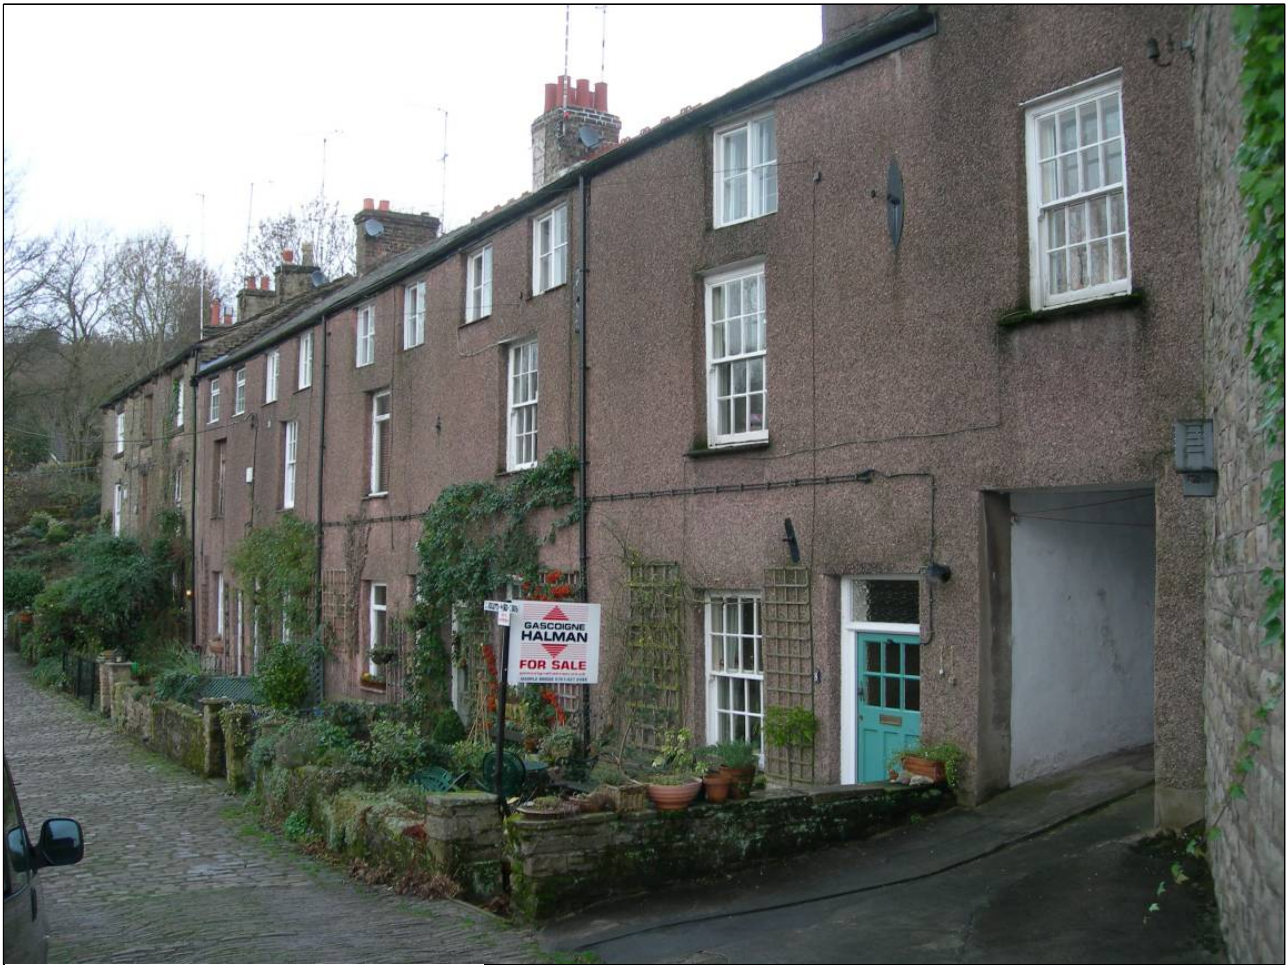
Weavers Cottages, Holly Vale

ridge level. There is a blocked-up taking in door at the second floor to the second bay. Square cut stone surround to the doors and a wedge shaped stone lintel and square cut projecting stone sill to the windows. Windows openings to the third floor are smaller. The middle cottage has a later porch. The roof level is slightly taller than that of No's 5-8 and the footprint not as deep. No's 5-8 are pebble dash rendered, with unusual arrangement of paired windows at top floor level. All likely to have been used as weavers' cottages.

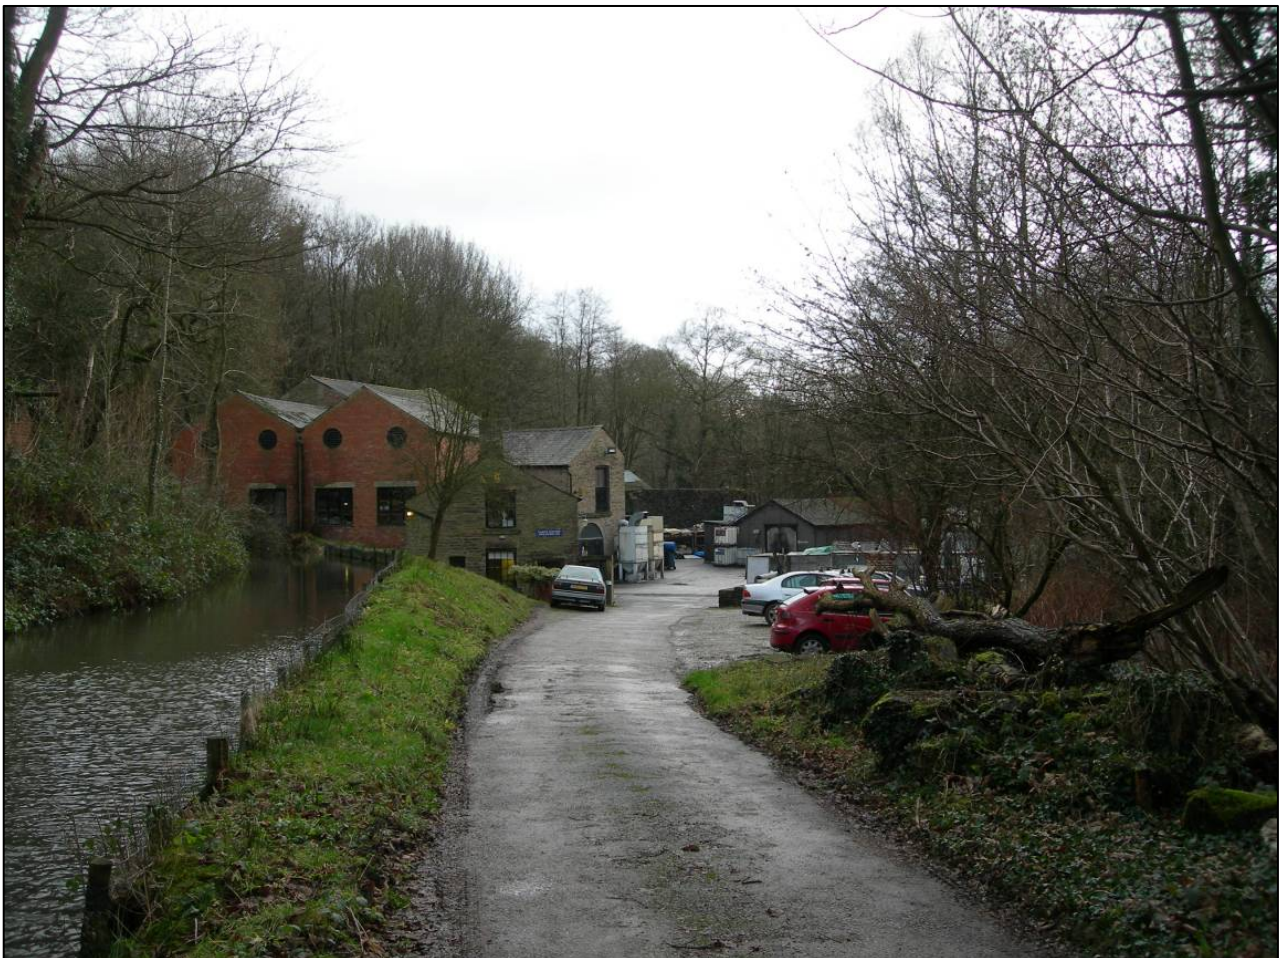
Primrose Mill

Believed to have originally been a fulling mill owned by the Stanney family and later converted for cotton spinning in the late C18; the buildings on site date in part to this date. Sturdy stone warehouse, brick warehouse and former domestic house remain, as does square stone chimney of mid-19th century date. Mill building converted in 1897 by Ramie Company for manufacture of gas mantles. From 1924-36 it was used as a dye works. The main mill was demolished after fire in 1962. Site now used for manufacture of synthetic materials. Of industrial archaeological interest.

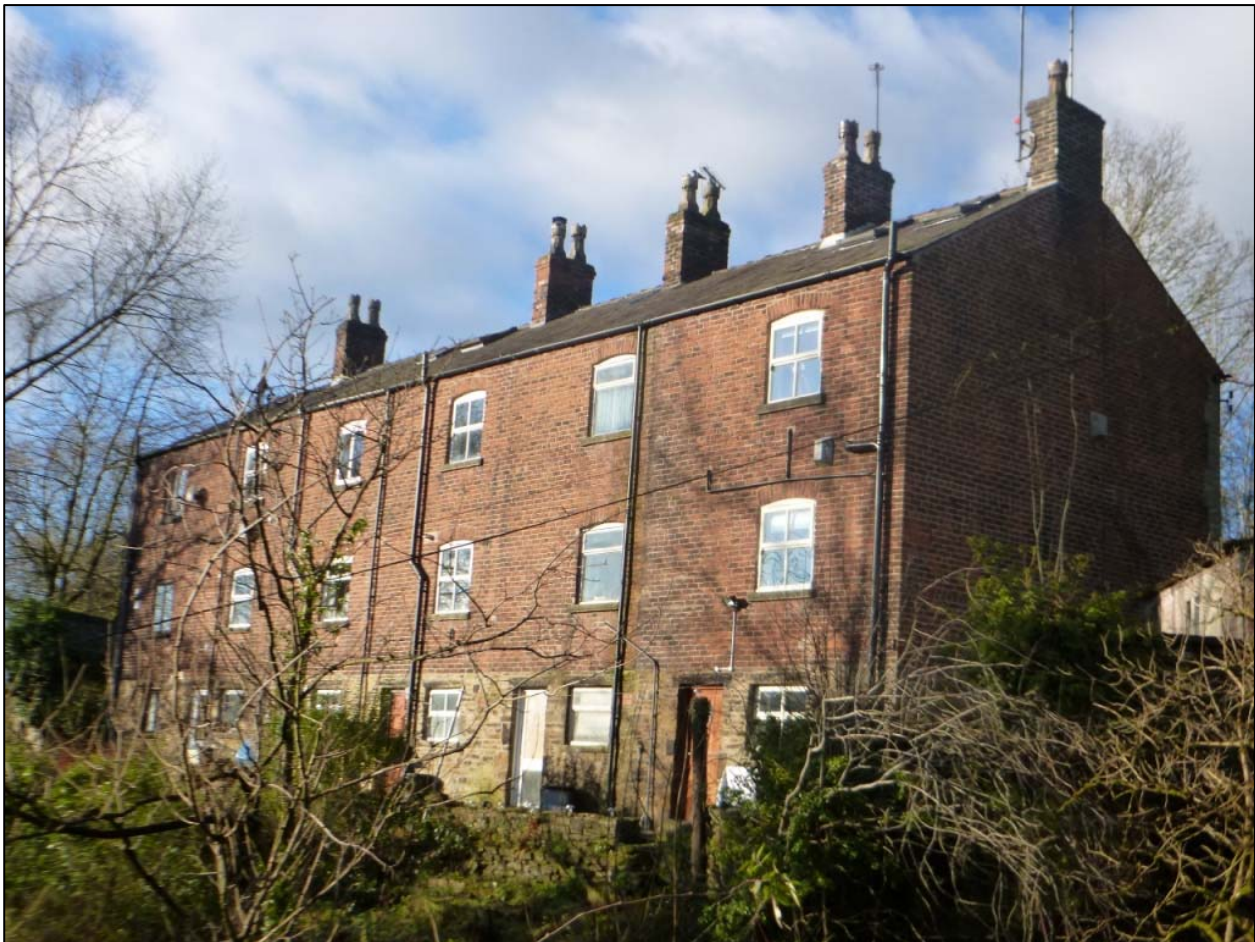
Row of 6 two-storey cottages with rears that extend downwards following the contours of the bank to give a 3-storey rear. Each terrace is of 2 bays with main entrance to the right. Stone front elevation with slate roof and stone chimneys. The rear is stone built to the ground floor with an entrance and window both with square cut stone lintels. The remaining floors are brick built with arched segmental brick lintels to the windows. Possible workers cottages.

View of the rear of 24-44 Mill Brow

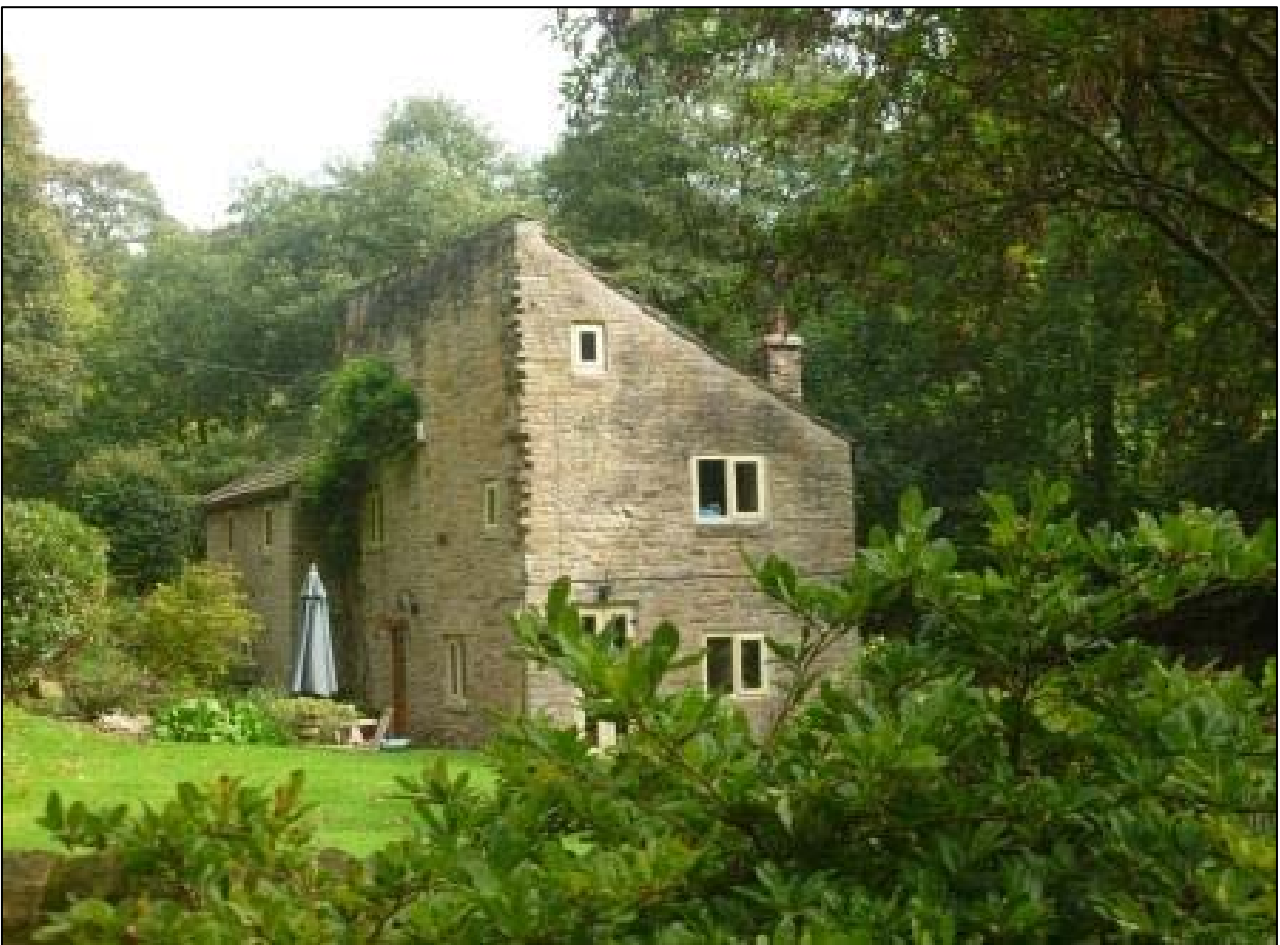
Brookside Cottage

Rectangular plan building of single-pitch roof construction with square plan, 2-storey, hipped-roof extension to the east elevation. Stone built with large stone flag roof and chimneys at eaves level. Window openings are small and randomly placed, most with square-cut stone surrounds. Stone to west elevation and extension is roughly dressed and coursed, but appears to be random rubble to north elevation. Known locally as the 'Salt Box'.

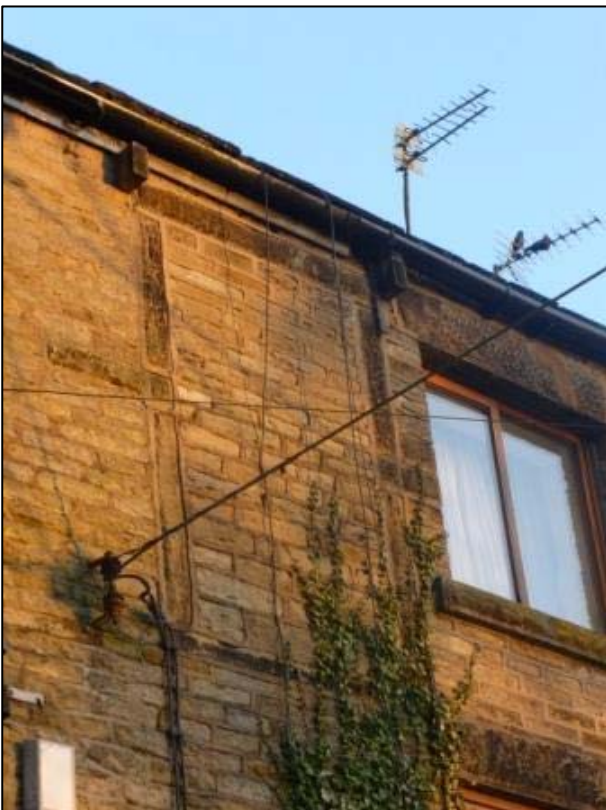
Mill workers' terraced housing, following the contours of the valley, was built in dressed stone, as at 1-3 Mill Brow Road or in brick, as at 12-22 and 34-44 Mill Brow Road, and is of late-nineteenth century date. The three-storeyed houses were weavers' cottages with garrets at top floor level. Distinctive features are the pairs of windows at the upper level at 4-8 Mill Brow Road and the blocked-up doorway at no.2 which may have been used as a taking-in door for goods or as a separate access for weavers.

Taking-in door at weavers' cottages

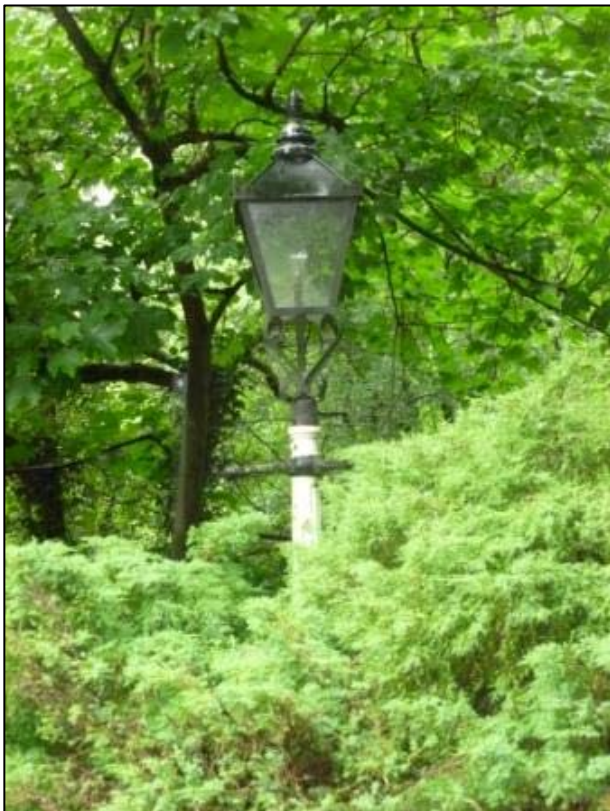
At the end of the drive to Primrose Mill there is a Victorian style lamp post, its date possibly coinciding with the conversion of the mill to the manufacture of gas mantles and thereby not only providing light but also acting as an advertisement for the products being produced in the mill. There is little in the form of decorative street furniture in the Mill Brow conservation area and it is important that what does remain is retained for the special interest it adds to the character of the area.

Lamp post at Primrose Mill

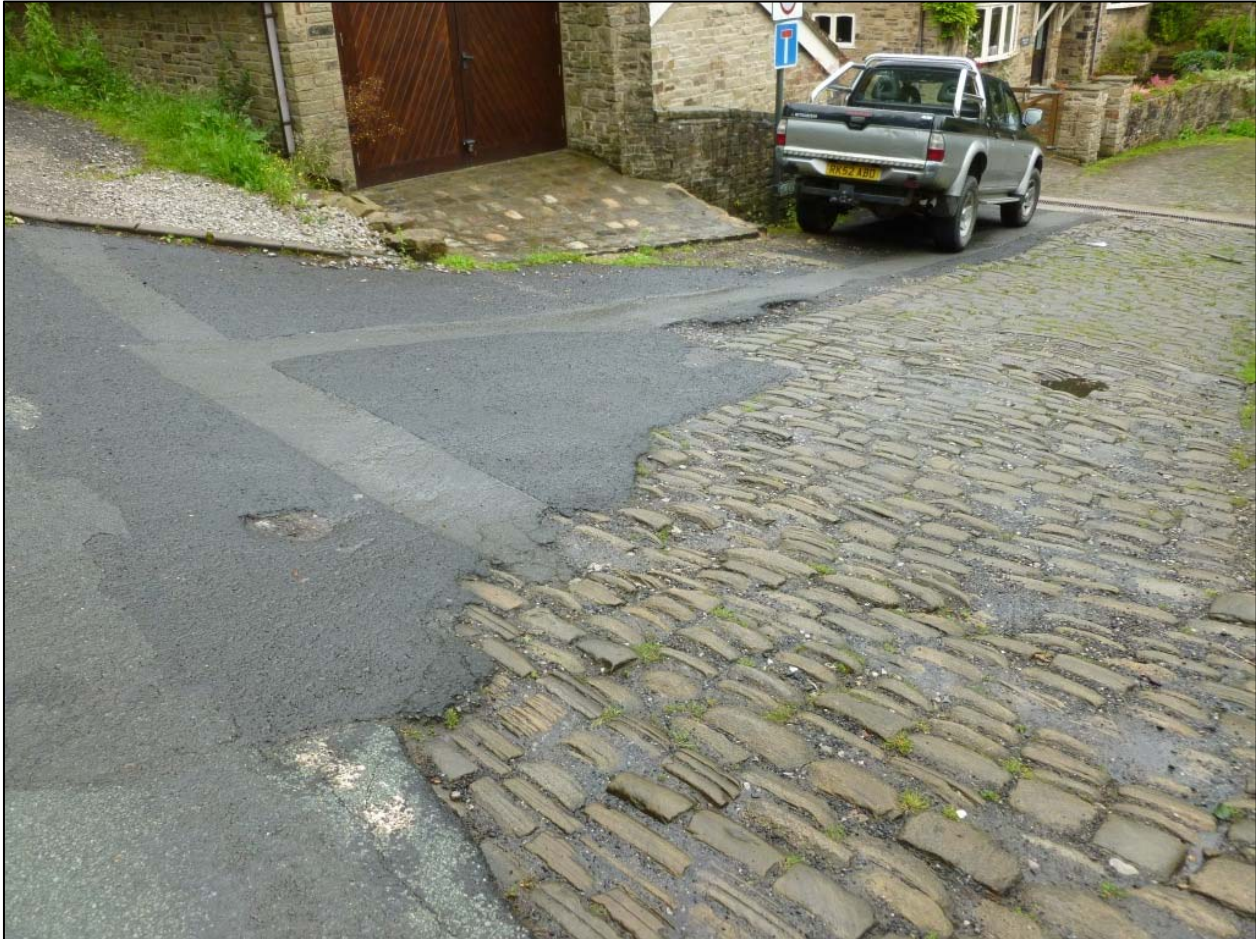
There is extensive loss of original street surfaces and there have been unsympathetic works carried out to those that remain, such as the tarmac overlaid on the setts at the entrance to Holly Vale. As there are so few of these architectural details remaining, it is important that extant examples are treated appropriately. A lot of the original street furniture has also been lost.

Setts at the entrance to Holly Vale & the intrusion of a modern road surface
